## Unsafe Aircraft Wiring Poses Expensive Problem

*Billions of dollars are likely to be spent before this bureaucratic web of deficient wire selection, sole source intrigue, and unexpected production stoppages is clarified. And, electronic equipment manufacturers may find themselves right in the middle of the controversy.*

*By Richard V. Hartman*

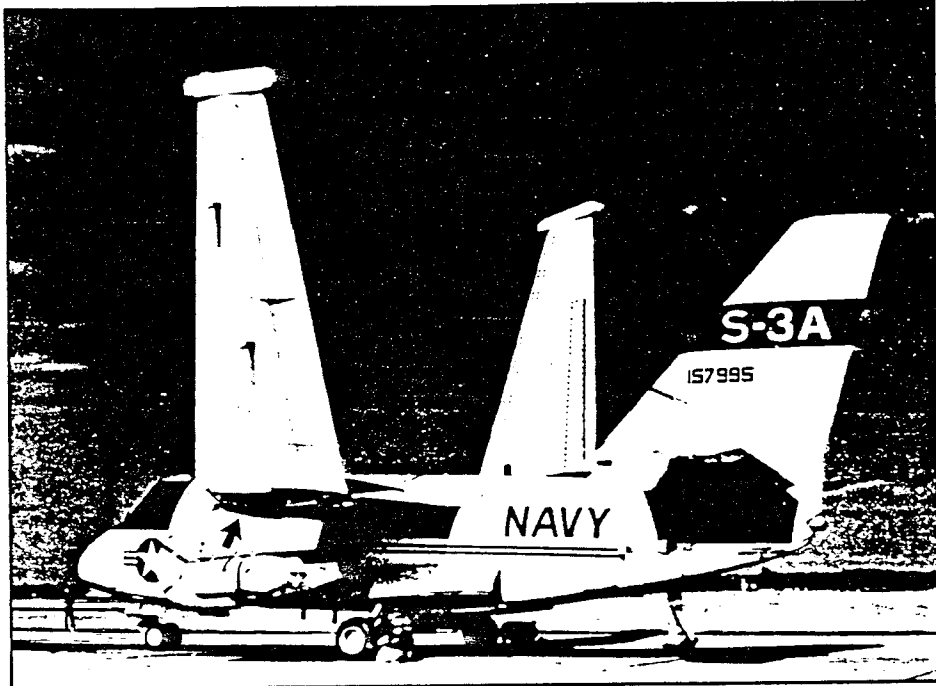
*The S-3 antisubmarine warfare aircraft poses particular problems. The arrow points to the high wiring failure rate wingfold area.*
